EFFECT OF SOIL PREPARATION TO THE QUALITY OF THE POTATOE COLLECTOR AND THE AMOUNT OF DAMAGE TO POTATOES

Frančák, J

Slovak University of Agriculture

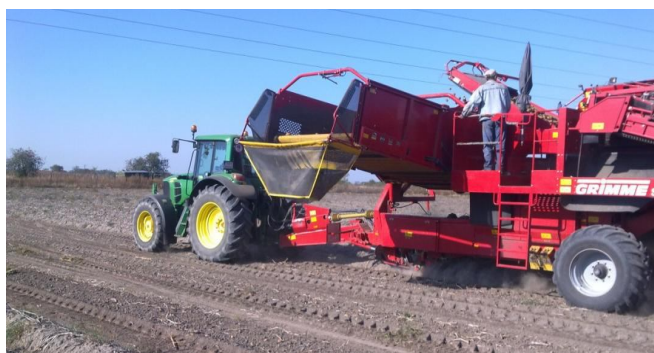
Figure 1 Two-line potato harvester Grimme SE 170-60

¹. Harvesting of potatoes was carried out, two-line potato harvester Grimme SE 170-60 in aggregation with tractor John Deere the 6930 Transport to potatoe store by 9 t lorry Š-706.

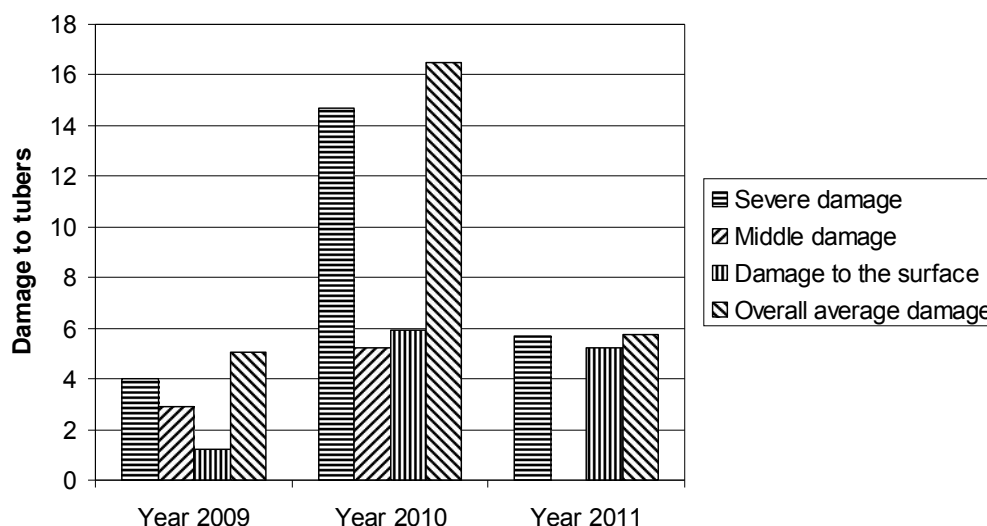
Figure 3 Graphical overview of potatoes damage

Yield was found out by digging tests. Damage was calculated by the arithmetic mean of 10 samples. Soil properties were very good, therefore the collected material was at least damaged. Important was the low percentage of severely damaged tubers.

The soil was heavy, clay, where the lumps were inadequate irrigation, also contained a large amount of stones. In preparing the soil before planting was used identical technology as in other years and was not made even stone elimination of soil. A major negative aspect was the high percentage of severely damaged tubers that sorting had to be scrapped to prevent material damage of taking over material.

The soil was light, sandy with good moisture, which had a positive impact on the quality of the harvested material. Important was the low percentage of severely damaged potatoes.
